# Manhole Inspection Summary

Manhole # S25II1017MH

Insp Date: **12/12/06 2:41 PM**

**Location** Address: **4146 ROLAND AVE**

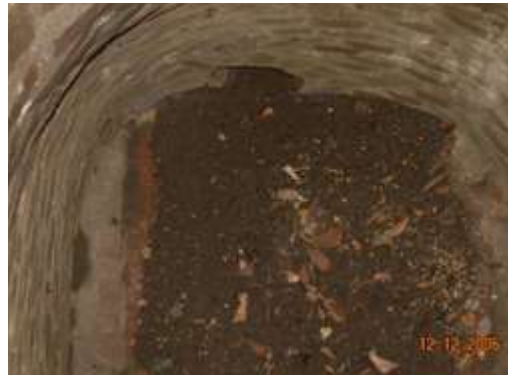
Top View

Channel debris.

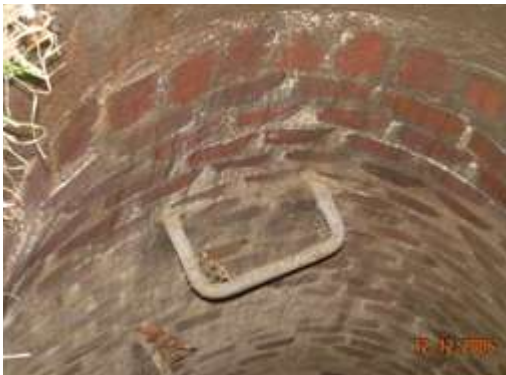
Defect

☒ **Leaks**

Infiltration: ☐ None ☒ **Joint** ☐ Cracks ☐ Mortar ☐ Roots ☐ Wall

Infiltration: ☐ None ☐ Joint ☐ Cracks ☒ **Mortar** ☐ Roots ☒ **Wall**

Frame leaks. Adjustment and Corbel infiltration.

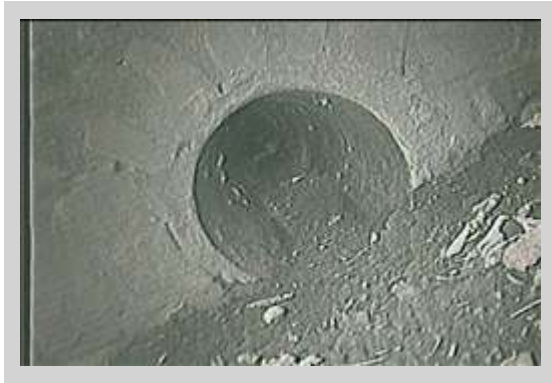
8 in. Circular Gravity Sewer  
Pipe Out @ 12 O'Clock

Deposits: ☐ None ☒ **Mud** ☐ Sludge ☒ **Debris** ☐ Grease

Silt Depth: **0.5** (in.) Deposits Extent: **Light**
